HIGH-TEMPERATURE COMBUSTOR LINER TESTS IN STRUCTURAL  
COMPONENT RESPONSE TEST FACILITY

Paul E. Moorhead  
Structural Mechanics Branch  
NASA Lewis Research Center

Jet engine combustor liners were tested in the structural component response facility at NASA Lewis Research Center in a cooperative program with Pratt & Whitney Aircraft, East Hartford, Connecticut. In this facility combustor liners are thermally cycled to simulate a flight envelope of takeoff, cruise, and return to idle. Temperatures were measured with both thermocouples and an infrared thermal imaging system.

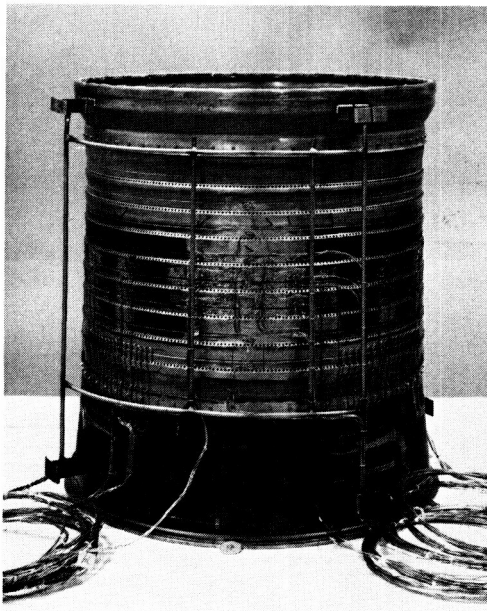
**STACKED-RING LOUVERED LINER**

One type of combustor liner tested was a conventional stacked-ring louvered liner. A second type under test is the "segmented" or float-wall combustor liner. The water flow and airflow through the test rig are controlled manually. The temperature cycling is controlled by a dual-loop programmable controller.
